## FIELD INSPECTION

| <b>Project Name:</b> | Mountain Valley Pipeline | <b>Inspector:</b> | Matthew Grant |
| <b>Inspection Date:</b> | Tuesday, February 5, 2019 | <b>Project Contact:</b> | Brian Clauto |

## FIELD INSPECTION PHOTO LOG

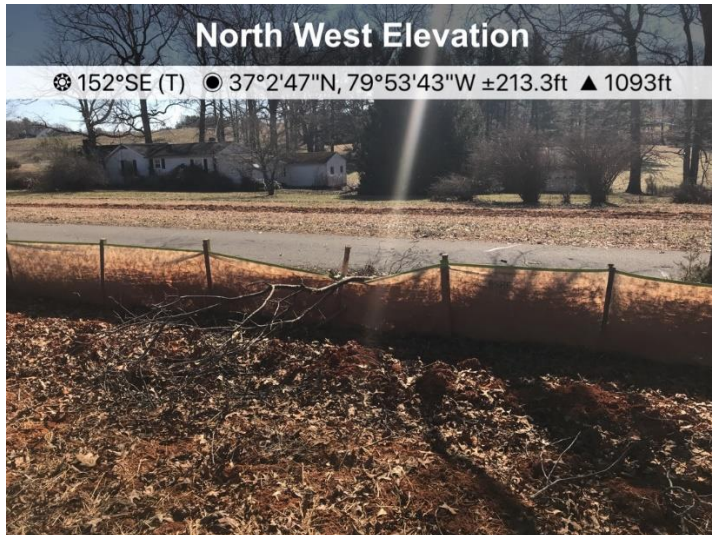
- Fig. 1 St#13955+05 P1 fence requires maintenance

**Recommended Corrective Action:** Maintain all controls per the approved plan and specs.

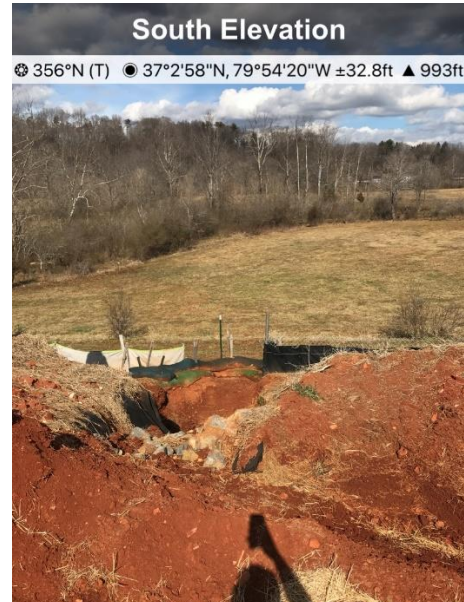
- Fig. 2 St#13919+00 sump inlet requires maintenance

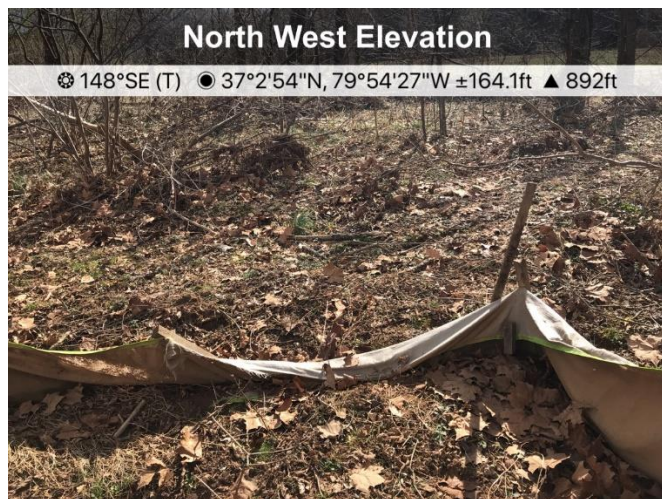
- Fig. 3 ATWS 698C P1 fence and CFS requires maintenance

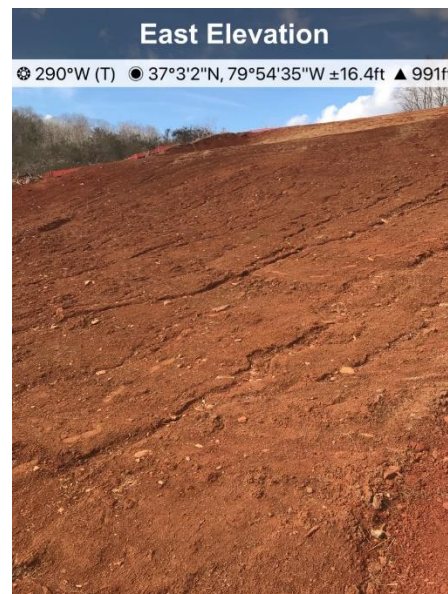
- Fig. 4 St#13909+08 slope requires repair and stabilization

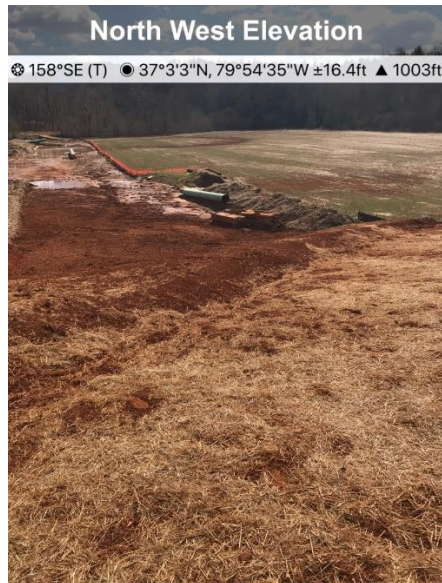
- Fig. 5 St#13906+077 waterbar exceeds 5%

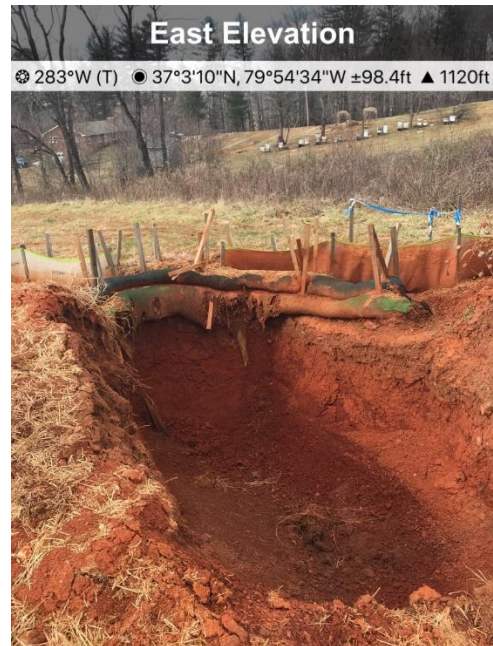
- Fig. 6 St#13899+92 sump end treatment requires maintenance

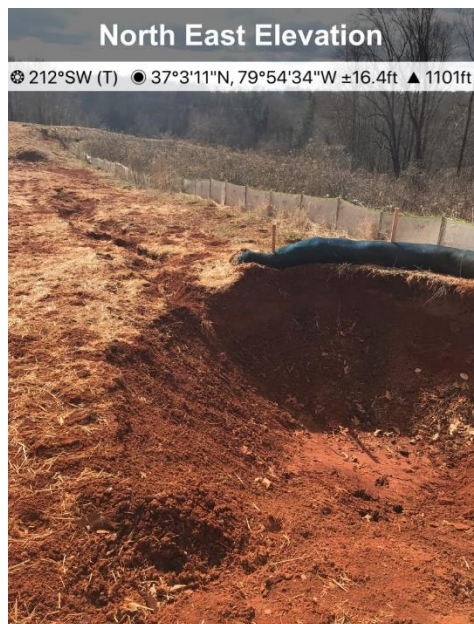
- Fig. 7 St#13897 sump requires maintenance

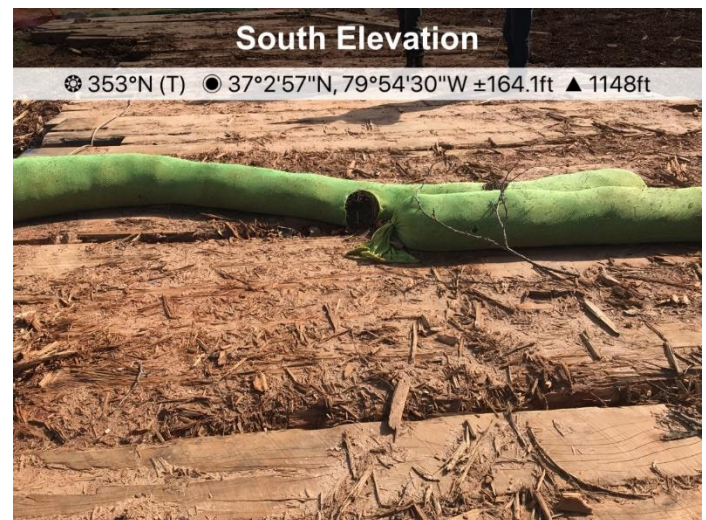
- Fig. 8 St#13875+73 CFS requires maintenance

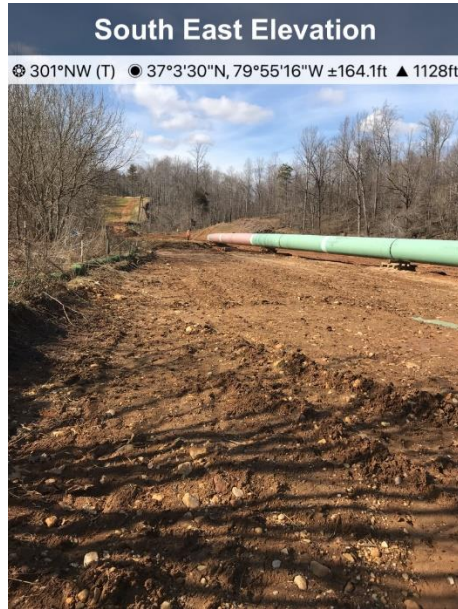
- Fig. 9 St#13869+00 area lacks stabilization near staged pipe and CWD

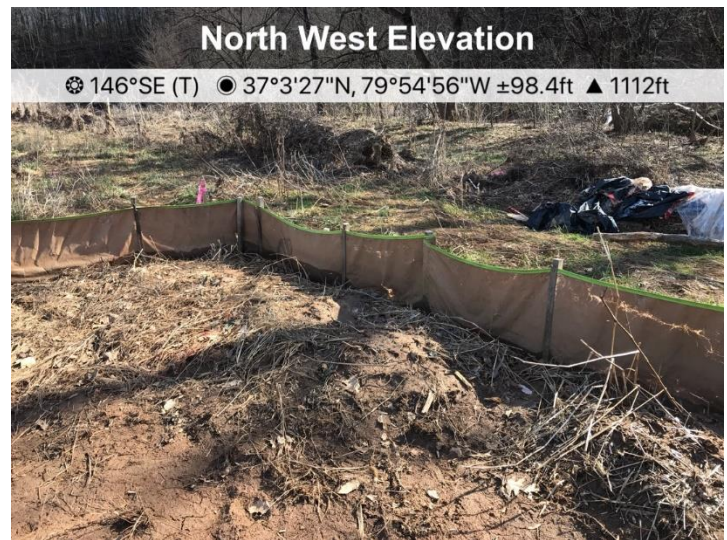
- Fig. 10 St#13877+00 P1 fence and CFS requires maintenance, trash beyond ROW.
